# VENTILATION IN NEW HOMES

A report of site visit findings

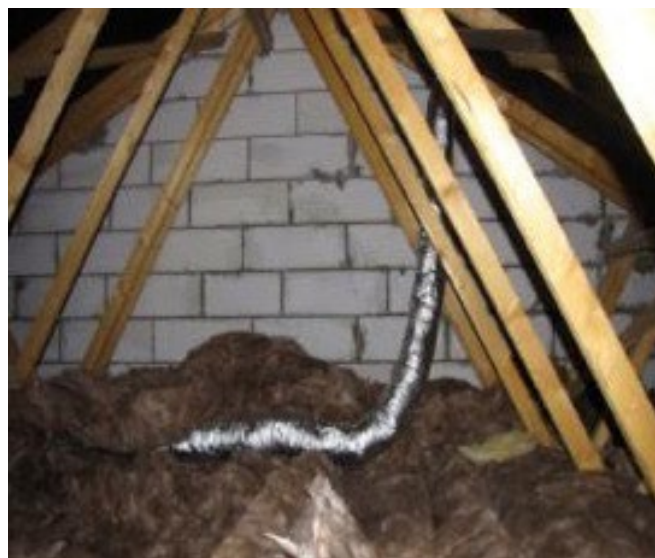
*Ducting at Site 3 – Long looping ducting could cause condensation to build up and increase the required fan power*

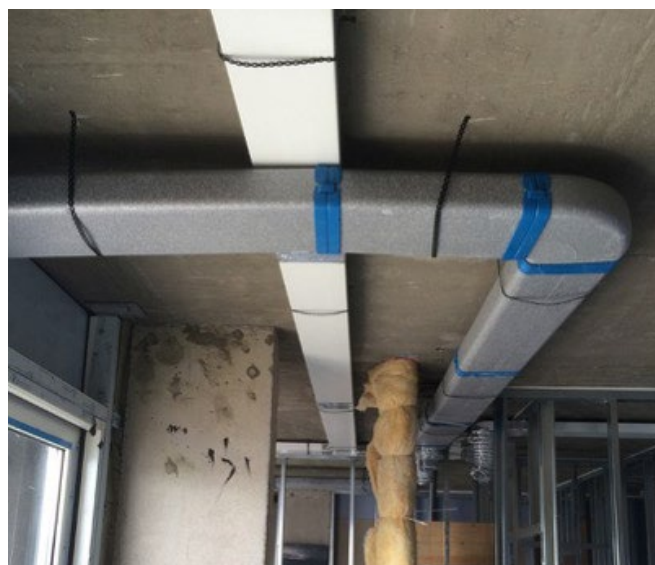
*Ducting at Site 2 – Rigid duct installation. Straight duct runs using proprietary bends where needed. Intake/exhaust ductwork is pre-insulated (grey ducting). Ducting mechanically connected and fastened throughout*

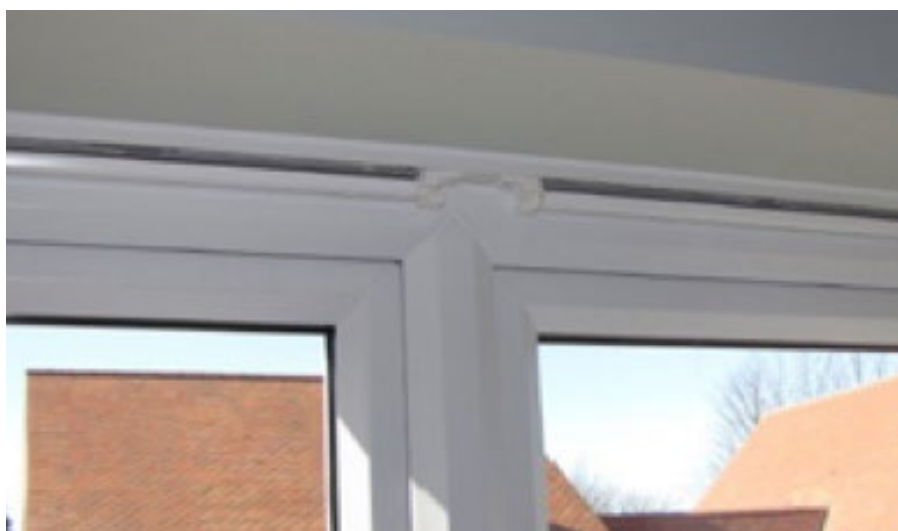
<b>Site 1</b>	No. All the windows installed had trickle vents, including the wet rooms. This was thought to be an error by the window supplier. There was also more than double the Equivalent Area required (see image below).
<b>Site 2</b>	Yes. The window company provided the correctly specified windows with no trickle vents as these are not required for an MVHR strategy.
<b>Site 3</b>	No. Contrary to the design, all the windows installed had trickle vents, including wet rooms. The units had nearly four times more Equivalent Area than required.
<b>Site 4</b>	Yes. The design of the trickle vent sizing and provision closely followed guidance in ADF.
<b>Site 5</b>	No. All the windows installed had trickle vents, including wet rooms.
<b>Site 6</b>	Partially. Trickle vent sizing and provision closely followed guidance in ADF. However the Equivalent Area size of ventilators selected were larger (4000mm <sup>2</sup> ) and more appropriate for naturally ventilated dwellings.

**Trickle Vents at Site 1 – Over-provision of trickle vents at Site 1. Two ventilators fitted with approximate EQA of 5800mm<sup>2</sup>. One trickle vent with EQA of 2500 mm<sup>2</sup> would meet ADF guidance.**

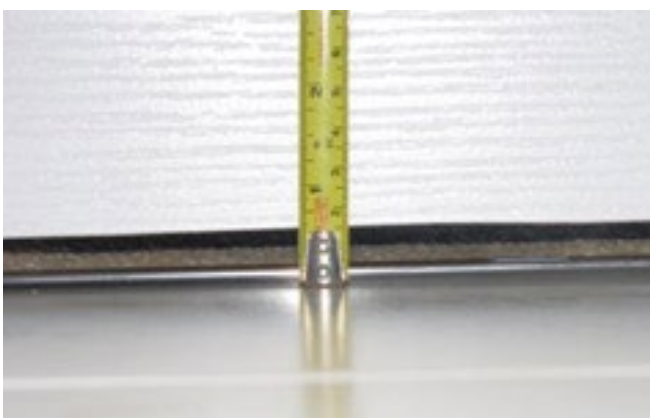
Site 1 – Example of sufficient door undercut: 15-20mm between carpeted and non-carpeted floor finishes – to allow 10 mm above carpet finish for undercut

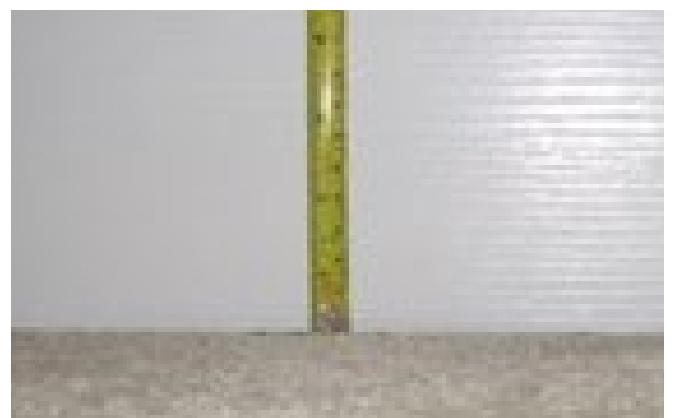
<b>Site 1</b>	No. Door undercuts were inconsistent. Approximately 20% of internal doors had door undercuts of <10mm in all the dwellings inspected.
<b>Site 2</b>	No. Door undercuts were inconsistent. Many were <10mm in the dwellings visited.
<b>Site 3</b>	No. Door undercuts were inconsistent. The Site Manager was unaware of the requirement for door undercuts. Approximately 35% were <10mm in the dwelling tested.
<b>Site 4</b>	No. Door undercuts were inconsistent. The majority were <10mm in all dwellings visited.
<b>Site 5</b>	No. Door undercuts were inconsistent. The majority were <10mm in all dwellings visited.
<b>Site 6</b>	No. Door undercuts were inconsistent. The majority were <10mm in all dwellings visited.

Site 1 – Example of inadequate door undercut

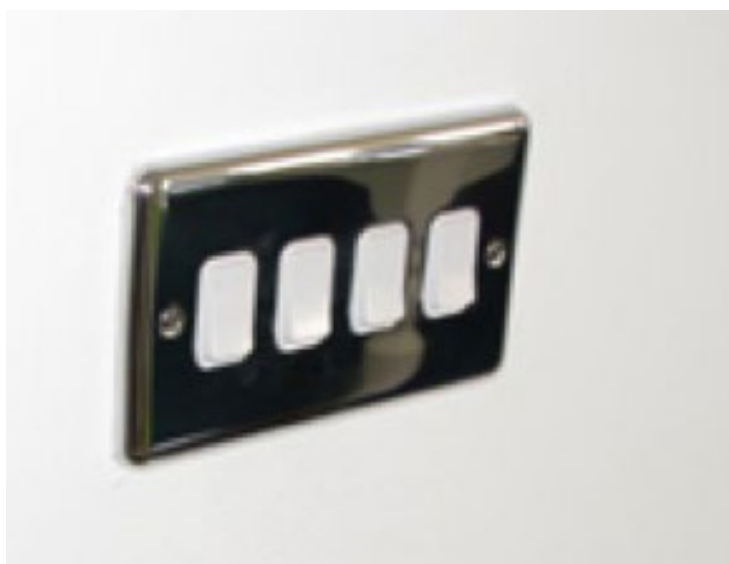
<b>Site 1</b>	No. Fan controls were not labelled apart from the isolator switch.
<b>Site 2</b>	No. Fan controls were not labelled apart from the isolator switch.
<b>Site 3</b>	No. Fan controls were not labelled apart from the isolator switch.
<b>Site 4</b>	No. Fan boost switches were unmarked.
<b>Site 5</b>	No real controls evident. Fan boost switches, where fitted, were unmarked. Some fans had no boost mode at all as they had been incorrectly wired to the light switch.
<b>Site 6</b>	Yes. Fan boost switches were labelled.

*Site 4 – Example of multi-gang switch. One of these is to boost the fan, but there is no labelling to tell the user which one*

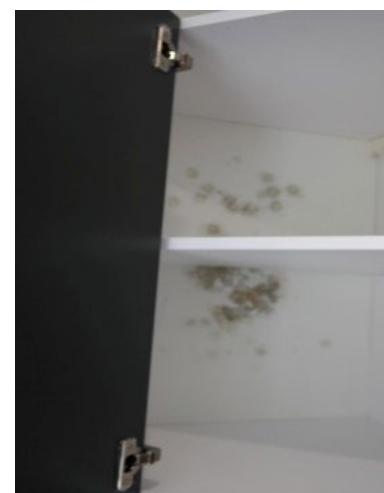
<p><b>Site 3</b></p>	<p>No. The sales team confirmed that homeowners complained of noisy fans and all isolators were switched off. As with Site 1, it is thought the reason systems were switched off was due to humidistats causing the fans to come on late at night. Occupiers were shown how to 'commission' the fans to reduce noise levels. The Show Home also showed signs of mould and condensation in the under-stairs cupboard and kitchen top wall cupboards potentially as a result of under-ventilation due to trickle vents being closed and fans switched off.</p>
<p><b>Site 4</b></p>	<p>According to the sales team, no information was available as the site was not yet occupied.</p>
<p><b>Site 5</b></p>	<p>No. The occupant interviewed had switched off the system at the isolators due to noise.</p>
<p><b>Site 6</b></p>	<p>Yes. The handover procedure was very good. There was a full explanation of the ventilation system carried out as part of the handover procedure. No issues were raised by occupants.</p>

*Mould in a cupboard in the Show Home at Site 3 – Example of the risk of under-ventilation, including during building drying-out phase. Sales staff had closed all the trickle ventilators and switched off fans*

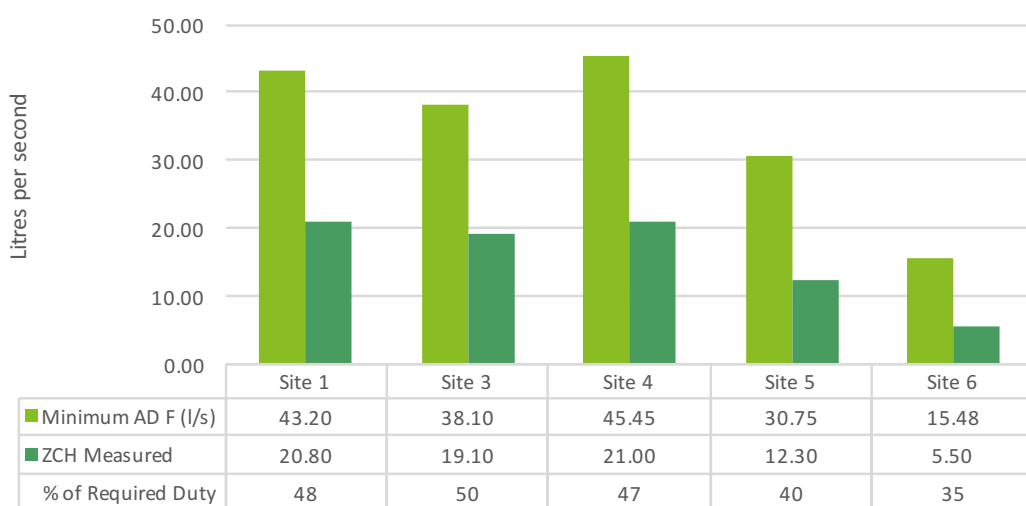
Chart 1a – MEV Measurements – Normal Setting

As chart 1a illustrates, none of the measured extract flow rates in any of the 5 dwellings met the minimum ADF values. The percentage of duty required is shown in the chart (light green stacks). Site 6 only delivered 35% of the required duty, whereas the best site, Site 3, delivered just half (50%) of the required duty.

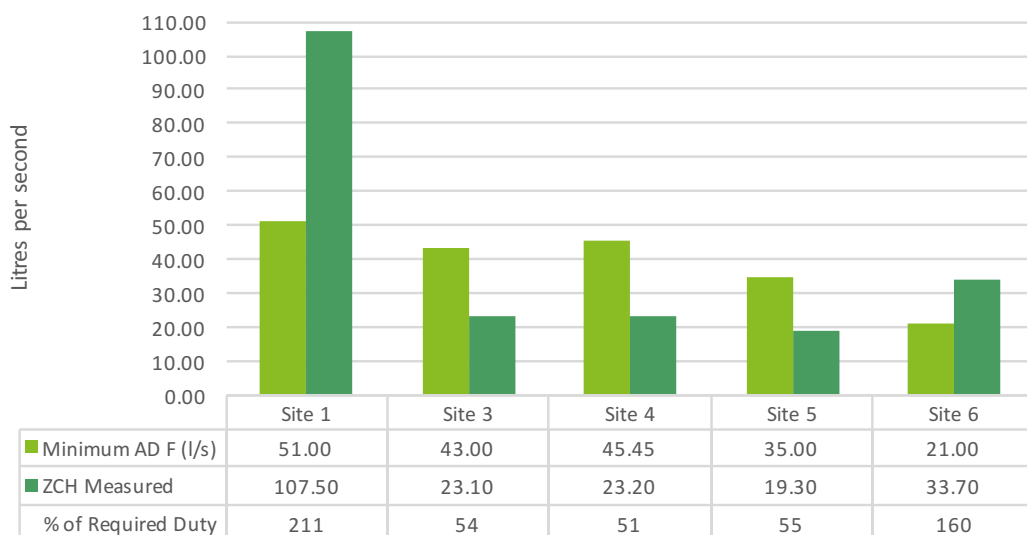
Chart 1b – MEV  
Measurements – Boost  
Setting

Chart 1b gives the minimum whole-dwelling extract flow according to table 5.1a (ADF). The minimum high extract rates for each room should be:

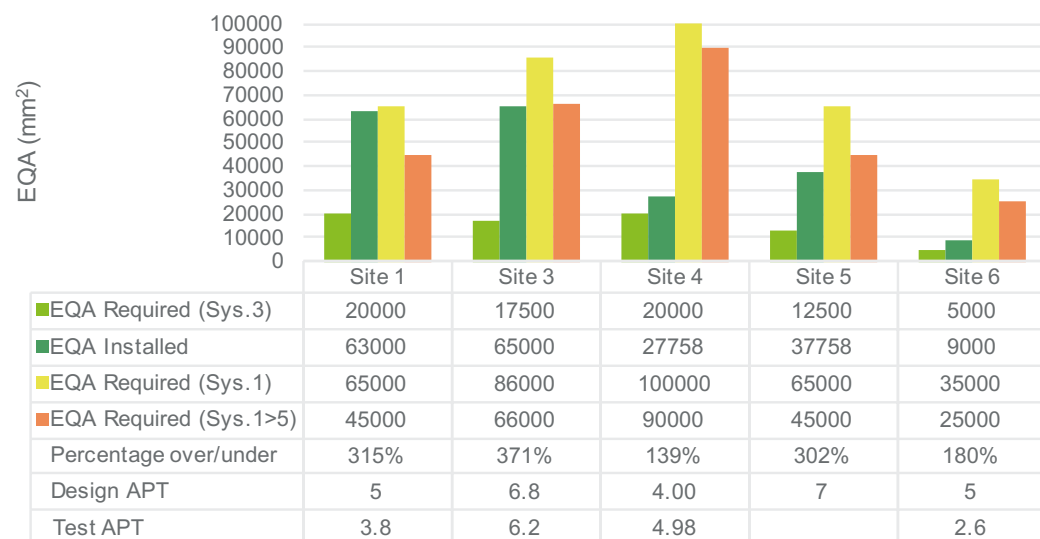
Chart 1c – Background Ventilator Equivalent Areas

The light green stack shows the background ventilator Equivalent Area (EQA) required in each property, based upon the 2500 mm<sup>2</sup> requirement published in ADF. The darker green stack, adjacent, shows the total EQA installed in each dwelling.

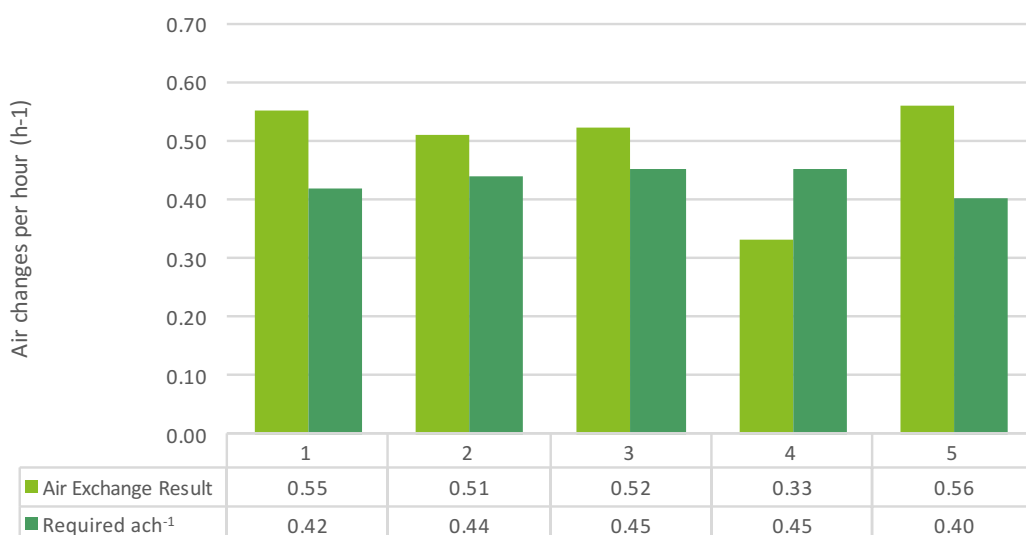
Chart 1d – MEV Air Flow and Air Exchange Measurements

As can be seen, despite the low performance of the fans demonstrated above, the measured air exchange rate is slightly better than the minimum required in all but Site 5 – this being the most sheltered of the sites, with the lowest wind speed on the day of measurement. Site 4, which had broadly the correct amount of ventilators, had a better than expected air exchange rate, but was also the most exposed (coastal/hilly) of all dwellings tested.

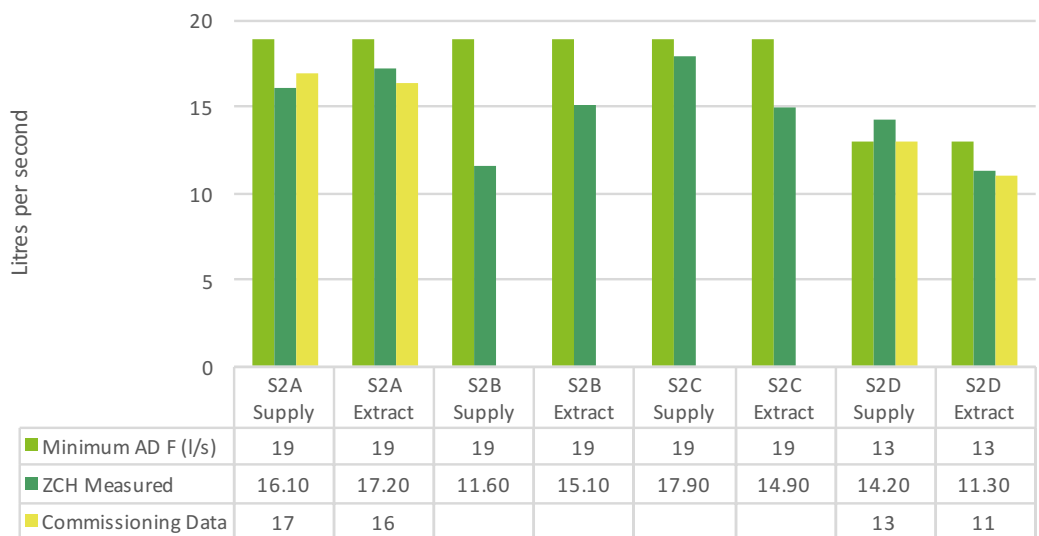
Chart 2a – MVHR Measurements – Normal Setting

Four MVHR-ventilated flats were reviewed, all within one development. The measurements taken during the field visits (dark green stacks) show that the measured air flow rates are less than the minimum recommended by ADF, with the exception of the supply air for flat S2D.

Commissioning values were only available for flats S2A and S2D, which showed a correlation with the values observed during the field visit. However, the commissioning data shows that the systems had been set to operate slightly below the minimum ADF requirement.

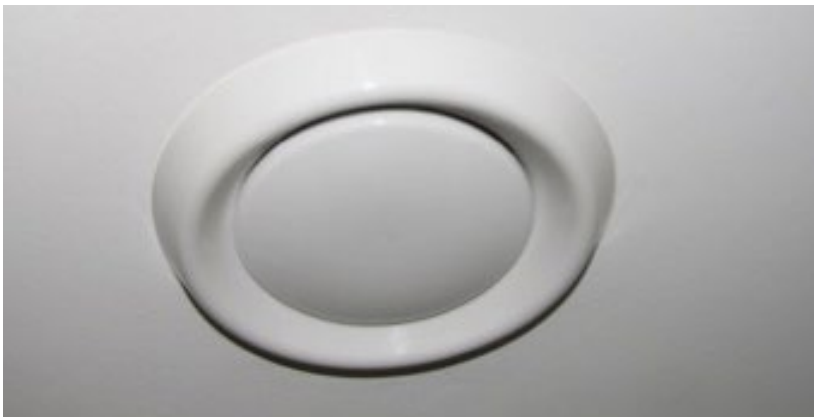
Visual inspection of each of the systems revealed an uncharacteristic finding in that all of the room air terminals were closed too tightly, with an air gap of between approximately 1-2mm around the valve opening, as the photo over the page indicates.

Site 2 – Example of room extract air terminal with inadequate air gap setting, leading to higher flow resistance and localised air velocity noise

The consequence of this tight setting is that, to achieve the air flow rate values, the fan speeds for both supply and extract needed to be set to higher speeds to overcome this resistance, thus the systems will be using more electrical energy than is necessary. The high fan speeds will likely cause noise nuisance.

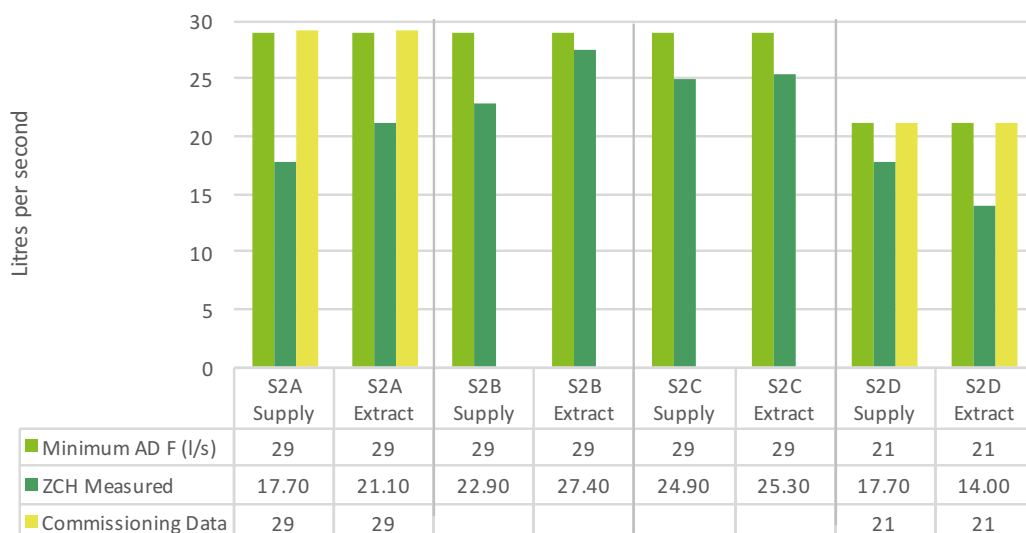
Chart 2b – MVHR Measurements – Boost Setting

The issue of the inadequate air gap setting on the room terminal valves is exacerbated with the increase in fan speed from normal to boost setting. In each flat, the fan settings for the MVHR in boost were set to near maximum capacity (45 l/s), whereas Chart 2b indicates the highest whole-dwelling flow rate (minimum ADF) in boost to be 29 l/s. However, the air flow rates measured by the project team range from as low as 14 l/s to 27.4 l/s, with none of the systems meeting the minimum ADF specification. It was also observed that the sound levels from the systems increased.

None of the systems were found to be satisfactorily balanced for both speed settings. It is of greatest importance that the normal speed setting, which is the most dominant, achieves reasonable balance. Only flat S2A achieves a balance of  $<10\%$  in normal speed, although boost is not well balanced for the same system ( $17.5\%$ ). The balance achieved for boost setting is good only in flat S2C ( $1.6\%$ ).

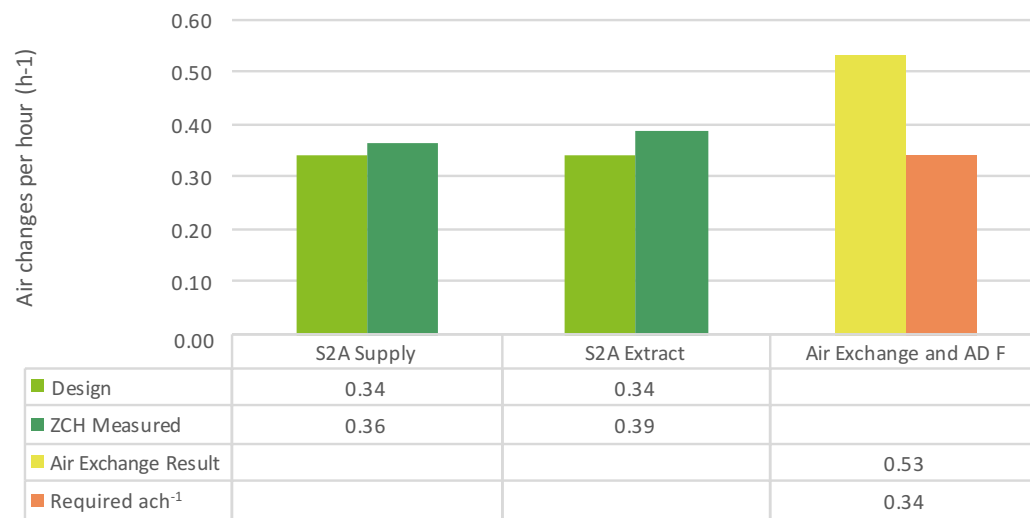
Chart 2c: Site 2 Plot A: MVHR Air Flow and Air Exchange Measurements

As illustrated, the minimum air exchange rate (0.34 ach<sup>-1</sup>) is met by the MVHR system. However, a further 0.19 ach<sup>-1</sup> was measured, giving a total measured value of 0.53 ach<sup>-1</sup>. The additional air exchange is likely due to the air leakage of the flat (3.8 m<sup>3</sup>/(h.m<sup>2</sup>) @ 50Pa) and the effect of wind on the ventilation system. The flat subject to this test was on the fourth storey and on a coastal location. Thus wind (approx. 1 m.s<sup>-1</sup> during the test) and exposure will influence the total air exchange rate.
