# VENTILATION IN NEW HOMES

A report of site visit findings

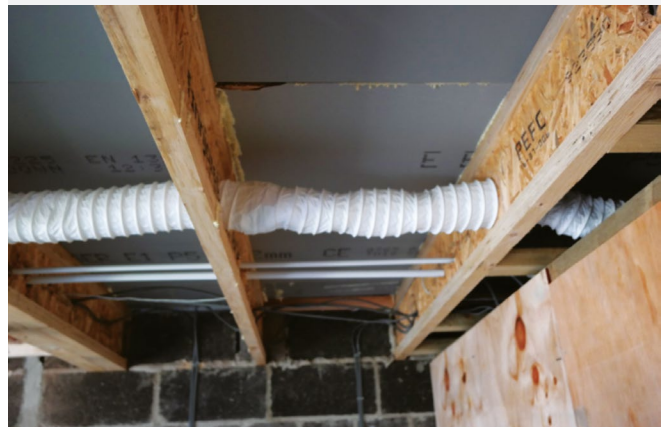
**An example of a common issue found was flexible ducting being installed in place of rigid ducting, and long duct runs of over 5 metres with multiple bends. This happened either because the drawings used had missed specifying the type of ducting needed, and/or rigid ducting had been specified but the design was not followed on site or was found to be impractical to deliver by the site team.**

Poor installation of flexible ducting leads to fans having to work harder to deliver the minimum ventilation rates required by Approved Document Part F of Building Regulations (ADF), and to systems being noisy.

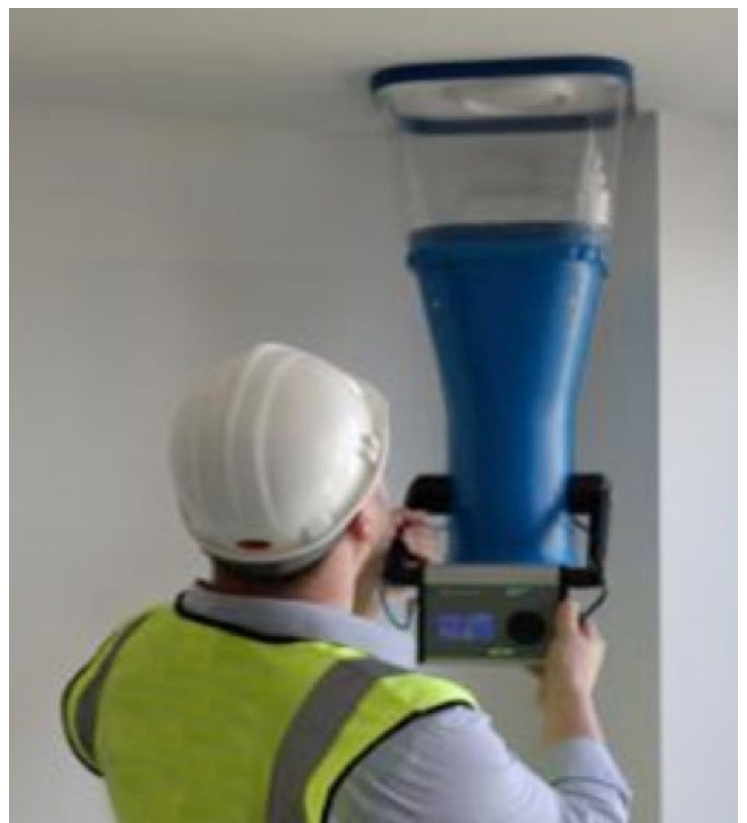
*Measurements of air flow rates being made by a member of the Hub team using a powered automatic compensating volume flow meter*
